UNITED STATES ENVIRONMENTAL PROTECTION AGENCY  
REGION 6  
1445 ROSS AVENUE, SUITE 1200  
DALLAS, TEXAS 75202-2733

June 16, 2015

SUBJECT: Impromptu visual cap inspection at the San Jacinto River  
Waste Pits superfund site

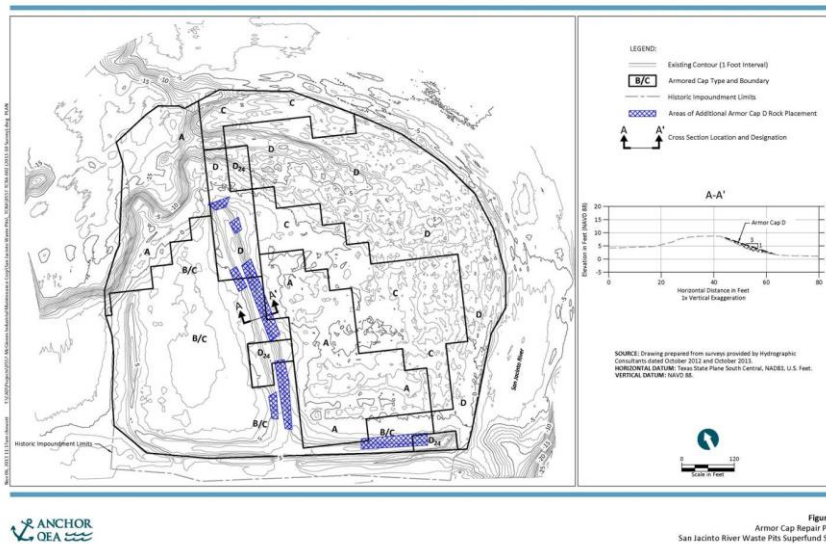
In addition to inspecting the overall integrity of the armor cap, seven additional areas (see Figure 1) were inspected where additional rock was placed and the slopes flattened to provide more stability and strength per the enhancement work plan dated November 2013. The section of the armor cap located above water level (western cell) was observed to be intact with no areas of cap erosion evident (see Photo 1-2). It was noted that several small areas of minor cap erosion along the central berm were evident by patches of the geotextile filter fabric exposed (See Photos 3-5).

Figure 1- Areas to be covered with additional rock and flatten slopes from November 2013 Armor Cap Enhancement plan

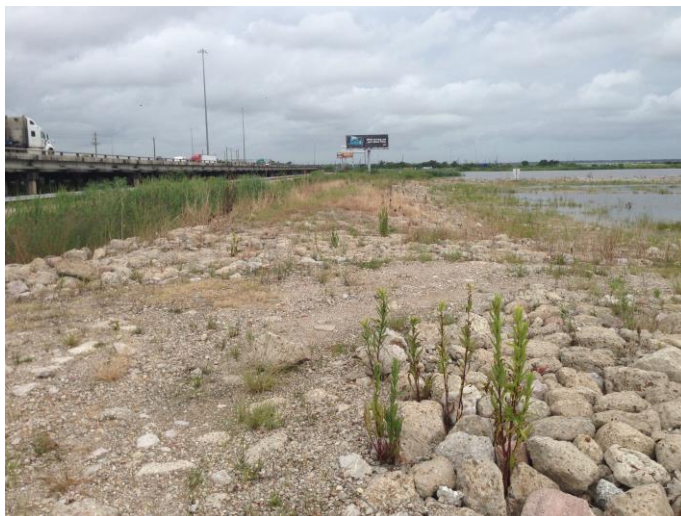
Photo 1- View of southern berm (looking west) and Western Cell surrounded by vegetative growth along San Jacinto River

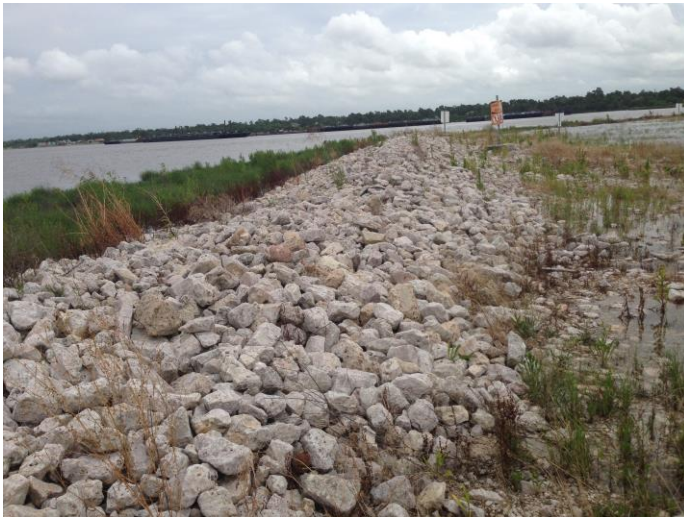
Photo 2- View of western berm along western cell (looking north towards San Jacinto River).

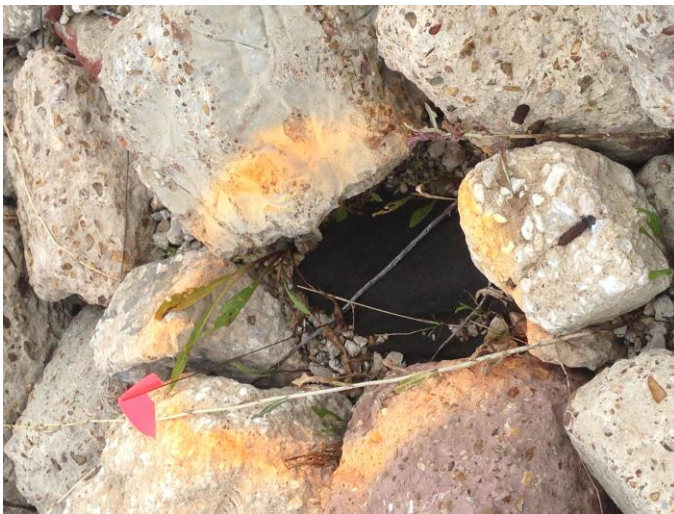
Photo 3- Magnified view of one area along central berm with geotextile fabric exposed

A review of the respondents TCRA monthly monitoring report dated June 15, 2015, have indicated no problematic areas needing cap repair or maintenance. However, due to this most recent visual cap inspection conducted on June 15, 2015, several areas of the armor cap are needing immediate attention. The first item needing immediate attention is the placement of additional armor material along the areas identified in this report, second, an additional application of weed control and maintenance is needed in areas with new vegetative growth, and lastly, a site walkthrough and removal of any vegetative growth that might obstruct site signage along the entire perimeter is needed.

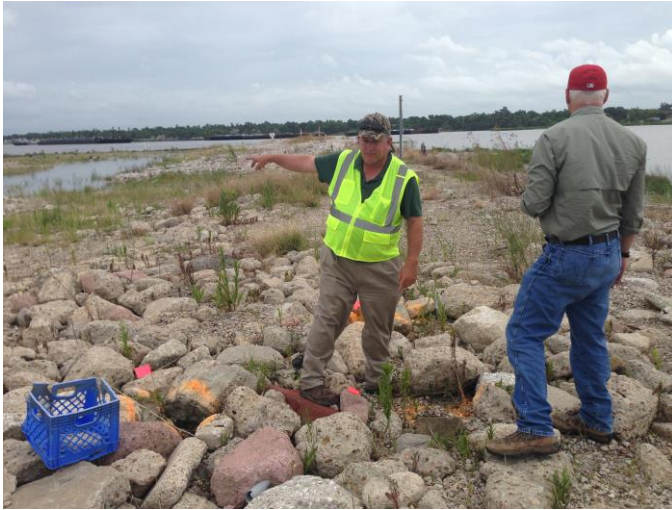
Photo 4- Areas along central berm (noted with orange paint) where geotextile fabric is exposed

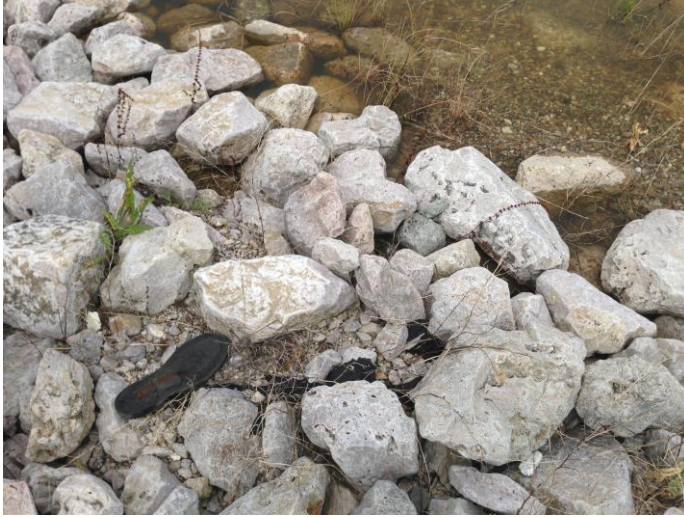
Photo 5- View of small area (note scale with size 10 shoe) where geotextile fabric is exposed which is located along the northern part of central berm and east along eastern berm.

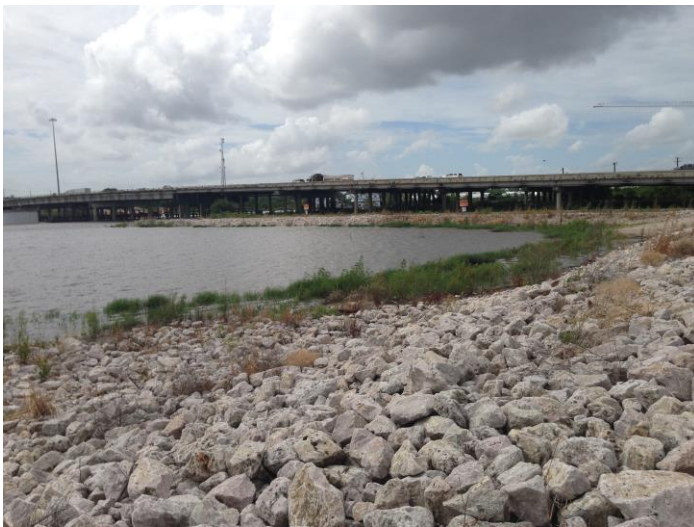
Photo 6- View of eastern cell looking south east towards I10

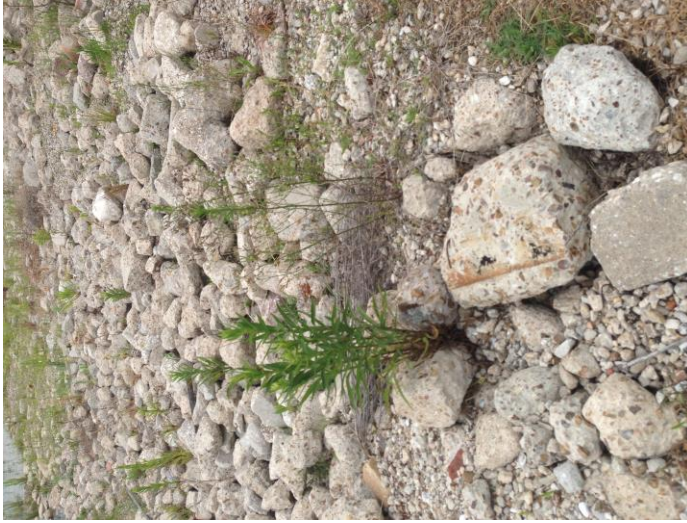
Due to the recent rains and flooding in the area, it was noted that a higher abundance of vegetative growth needing maintenance and control is needed (See Photo 7). It was noted during the cap inspection that prior vegetative maintenance and control was evident due to the brown and dead weeds, however more aggressive treatment and additional applications are warranted due to the increasing appearance of new vegetative growth.

Photo 7- View of vegetative growth along eastern berm.

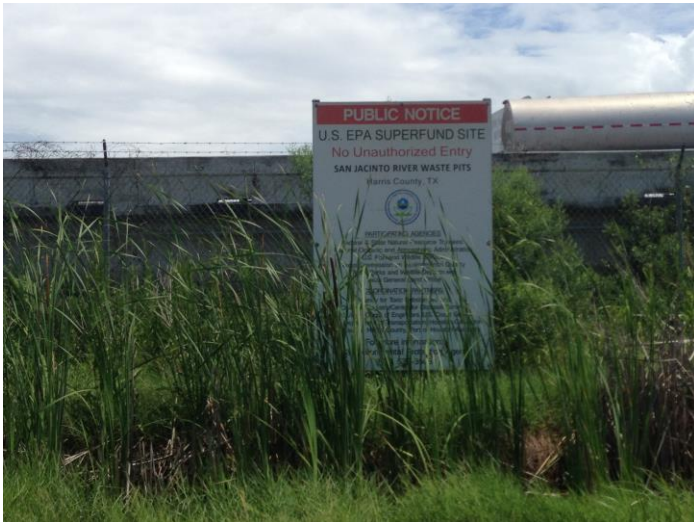
On June 15, 2015, EPA RPM Leos conducted a site visit to document observations at the San Jacinto River Waste Pits superfund site. During the site visit it was noted that the Site security fencing visible and intact. Site signage placed along the fencing perimeter was visible and intact with the exception of the southern gate located south of I10 which has an overgrowth of weeds and shrubs obstructing part of the signage (See Photo 8).

Photo 8- View of vegetative growth obstructing site signage near southern gate south of I10.
